Failure Analysis of a Boiler due to Thermal Stresses

Key Words: Boiler, Leakage, Thermal stress

Material: Gray cast iron

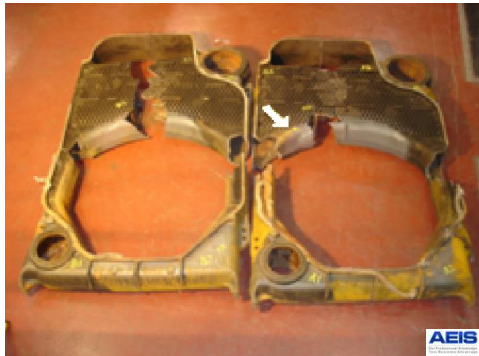
In figure 1. Examination of the fractured edges of the pieces showed that there was only one piece, arrow, in Figure 1, that had cracked during service. This section will be referred to as Section A and the other section as Section B in failure analysis.

Figure 1: Assembly of broken segments of the Boiler Sections

The failed segment of Section A, marked with an arrow in Figure 1, had cracked at both the edges. Both the cracks are in the parallel indicates that the stresses and localized material defects responsible for the cracking. The flame path runs along the surface of the crown in a plane normal to the cracks suggesting that the stresses could be the result of the differential temperature between the crown area and the restraining baffles at the back on the water side, showed in figure 5.

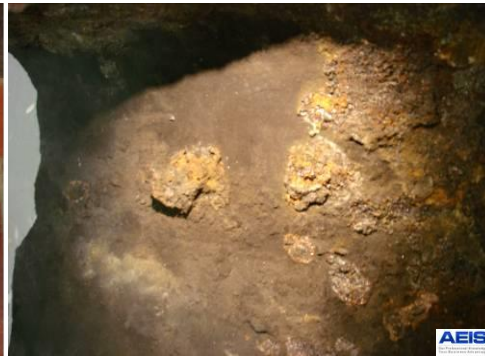
The inside surface (waterside) as noted through the broken ends, had deposits up to a thickness of about 1/8 inch as shown in Figure 2. No evidence found to indicate corrosion pitting or appreciable thinning.

Figure 2: Deposits on the inside surface (waterside) of the fractured segment

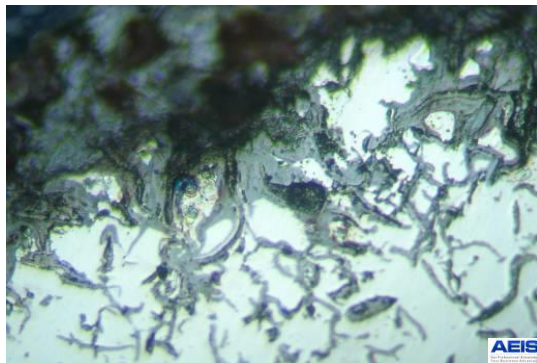
Cross-section of fracture edge and non heat transfer location of Section A were metallographically prepared for examination. Figures 3 showed corrosion attack in general and around the graphite flakes on the water side up to depth about 0.020 inch.

Figure 3 Corrosive Attack on Water Side
 Surface 375X Magnification

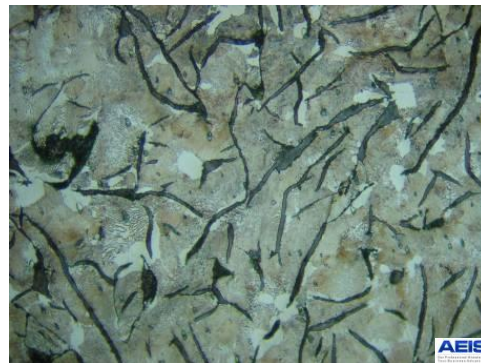
The bulk of the microstructure at the core was graphite flakes in a matrix of pearlite with some ferrite as shown in Figure 4. Transformation products of pearlite to ferrite at various stages could be seen between the surface scale and the core structure. No martensite was observed at all.

Figure 4 Section Core Microstructure
 375X Magnification

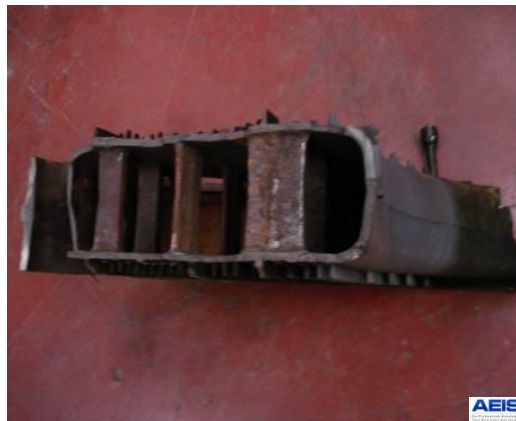
Figure 5 Restraining Baffles Behind Crown
