Failure Analysis of A Bus Radiator Core due to Deficient Soldering and Fatigue

Key Words: Radiator, Leakage, Soldering, Fatigue

Material: Brass

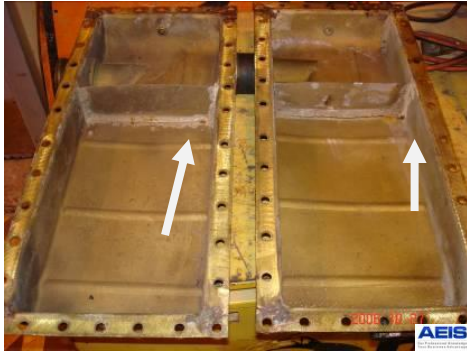
One of the Radiator cores was marked as 'leaking', and one is not. In figure 1-4, examination of the radiator cores shows cracks various sizes were observed at the baffle joints, solder around tubes on both cores. The "leaking" core showed a higher concentration of cracks at the periphery tubes on one of the plates.

Figure 1: Cracked baffles

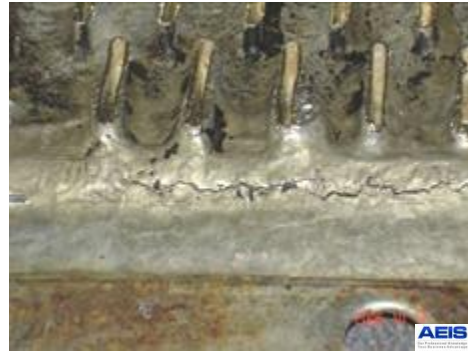
Figure 2: Crack along the edge of the cover plate of leaking radiator

If the cores were hydro-tested satisfactorily after manufacture it would be evident that there was no leak to start with. All the same the weaknesses, such as observed during the investigation, provided sufficient sensitive spots (stress raisers) where the combined action of residual stresses, hydraulic, thermal and cyclic stresses produced by vibrations in service were sufficient for generation and propagation of fatigue cracks observed in figure 10. The effect was most severe at the corner and the edges of the cover plate due to the geometry of the base components.

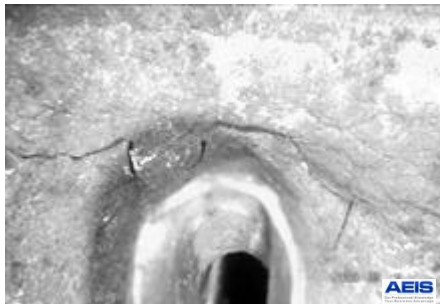
Figure 3: Cracks in the solder at header plate surface in leaking radiator

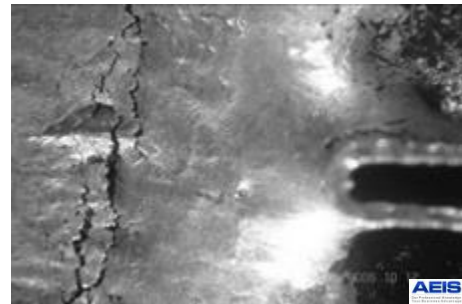
Figure 4: Cracks in the solder at header plate surface in the leaking radiator

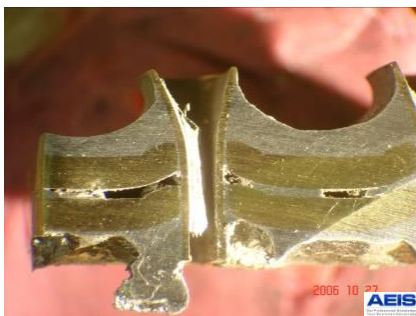
Several suspect specimens were cut for examination of the cross section to determine the leak path. Figure 5 shows the void between the cover plate and the header plate with a continuation crack to the outside of the core. Figure 6 is collage of photographs that illustrate such an area that forms a void which eventually may form the leak path.

Figure 5: The void between the cover plate and the header plate

From the above observations it is clear that the leakage had taken place through the cracks and voids in the solder. It is also clear that the soldering did not join the metal surfaces and voids were present. The solder composition is far from homogenous where significant percentage of lead was detected. There is a possibility that more than one solder composition was used to fabricate the radiator assembly. Some diffusion from adjacent species can take place. Overall, the filler material is unlikely to have uniform solidifying characteristics, such as the pasty temperature range, wetting properties and spread.

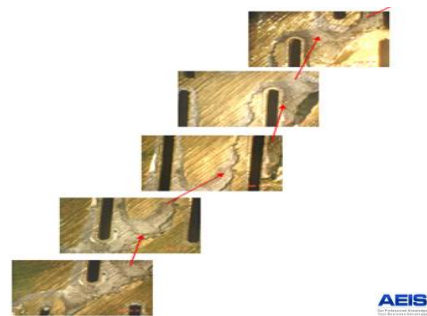
Figure 6: A collage of macroscopic photographs showing formation of a potential leak path

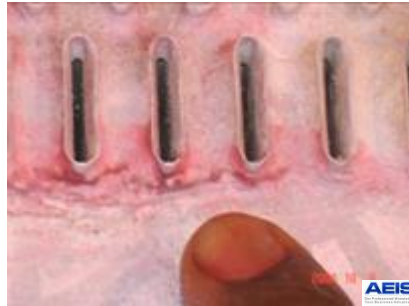
Dye Penetrate Testing of suspect area confirmed the presence of cracks, Figure 7.

Figure7: Cracks in the header plate to tube joint of leaking radiator

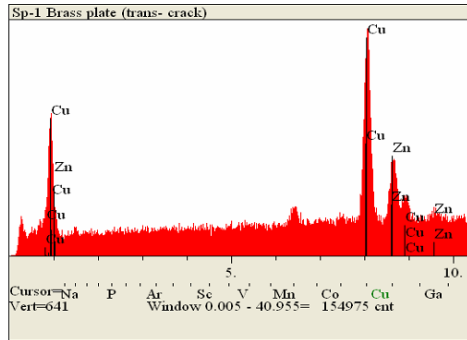
Energy dispersive x-ray spectroscopy (EDS) performed on the two plate cross sections showed that the plates are 70/30 Brass Figures 8. The solder, rich in Tin, showed a variation in chemical composition at spots. Some spectra are shown in Figures 9.

Figure 8: Chemical analysis of radiator core plate

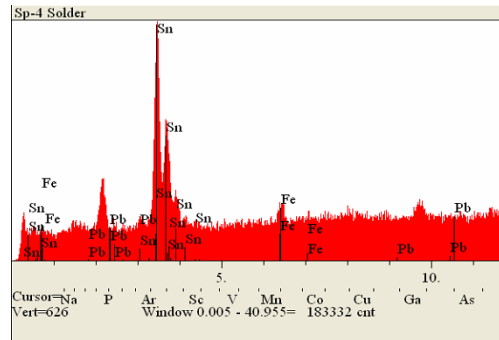
Figure 9: Chemical analysis of cracked solder

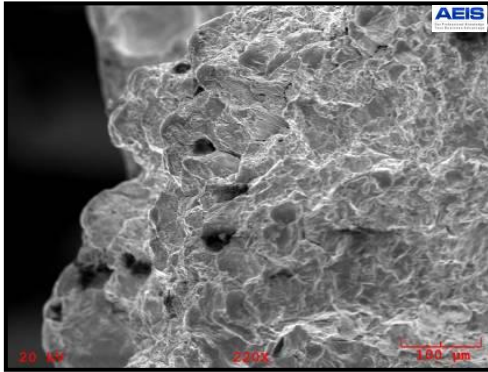
Electron Microscopy(SEM). The fracture face showed inter-granular nature of cracks. Fatigue striations were observed in regions that were comparatively flatter, Figure 10, 11

Figure 10: Crack that was forced opened at 220X Magnification

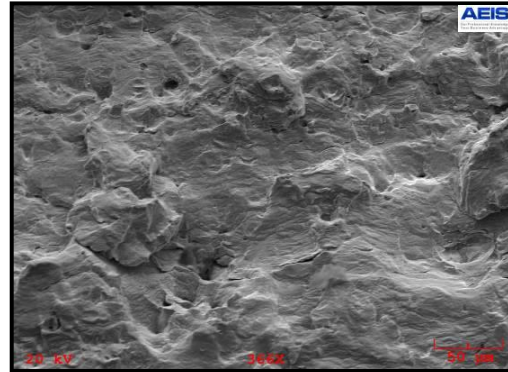
Figure 11: Fracture face of solder showing fatigue striations at 366 X Magnification

From the above observations and discussion it is concluded that the radiator core leakage took place through the solder layers above the cover plate. The cracks originated from deficiencies in the solder and propagated under cyclic service stresses till a definite leak path was established.
