Failure Analysis of Diesel Engine Crankshaft due to Overload and Welding

Key Words: Diesel Engine, Stress

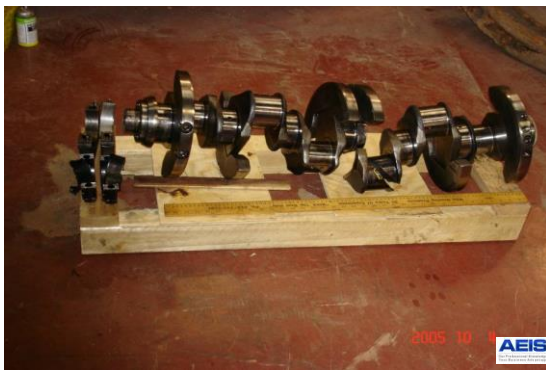
Figure 1: Crankshaft in as received condition

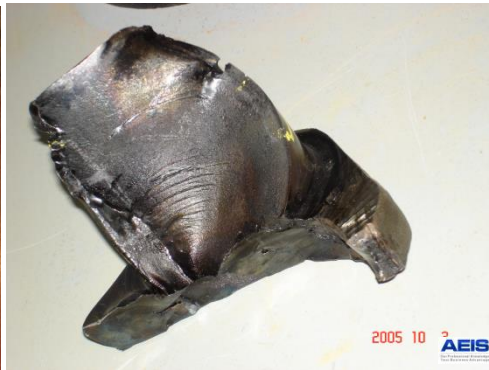
Figure 2: Fracture surface on the broken middle piece.

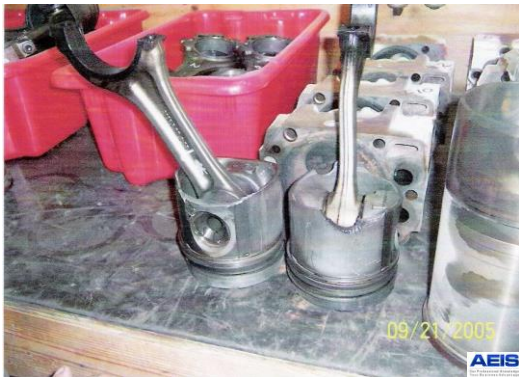
Figure 3: Damaged pistons and connecting rods.

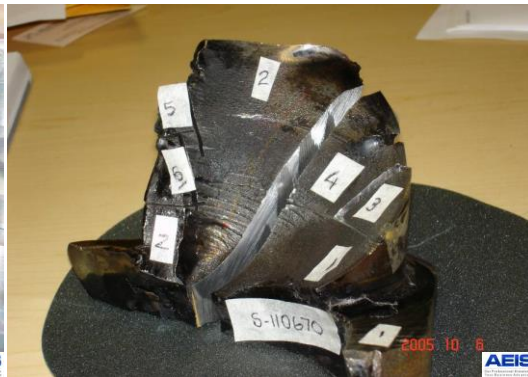
Figure 4: Sectioning location on broken middle piece of the crankshaft.

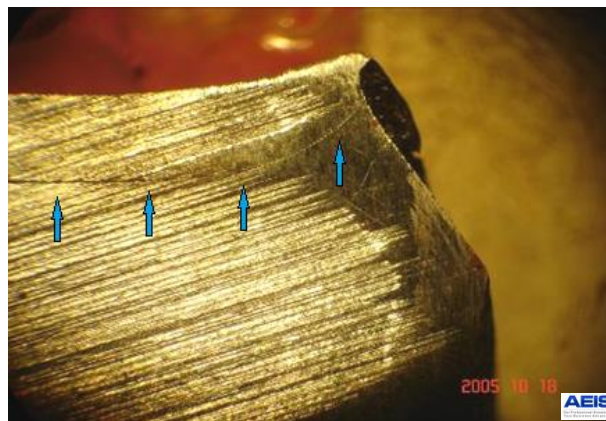
Figure 5 :Showing crack connecting the fracture surface to the fillet of the rod journal.

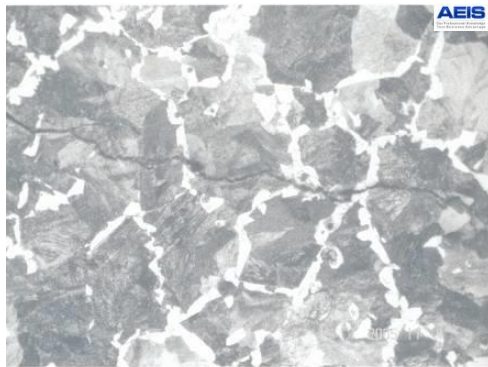
Figure 6: Microstructure below the fillet of the fractured journal showing a trans-granular crack. 275 Magnification

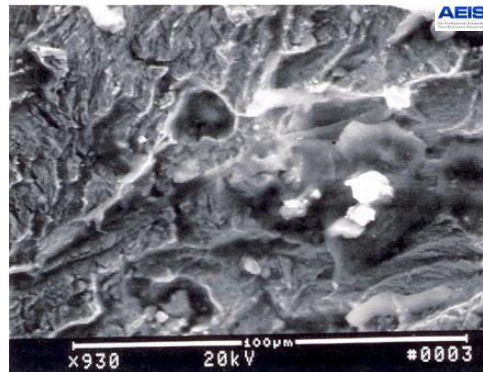
Figure 7: Fracture Surface at location 3. 930X Magnification
