Failure Analysis of Diesel Engine Cylinder Liners due to Cavitation Damage

Atlas Evaluation & Inspection Services

Failure Analysis Case Study

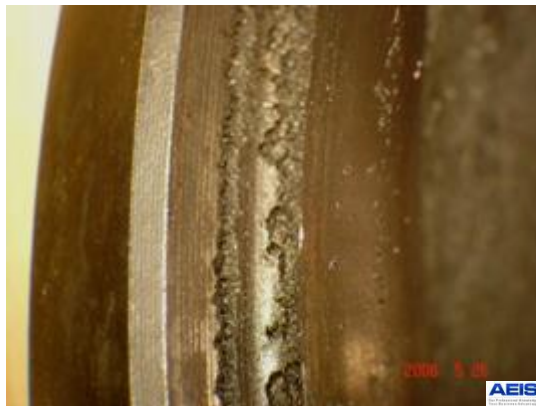
Cylinder Number 277 in Fig 1&2 showed pitting and erosion on the outside surface. Cavitation was also observed in isolated regions in the cooling channel. Approximately 1/16 inch deep grooving immediately below the flange was observed. Attack was also observed on the lower face of the flange. A crack on the other side of the wall i.e. on the internal surface was apparent. Some scoring was observed in a band approximately 1/8 inch at the upper edge of the crack.

Figure 1: Cavitations immediately under the flange

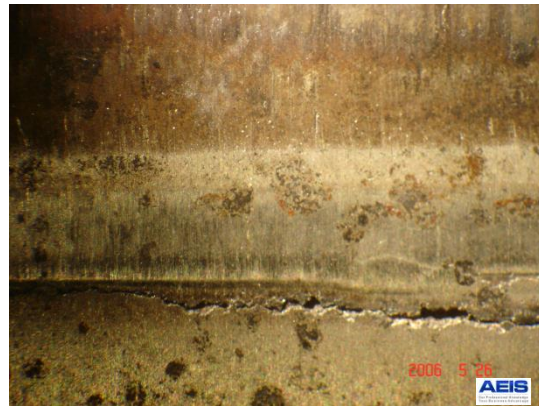
Figure 2: The crack and the scored band on the inside surface

Crack on cylinder 227 can result from an axial force that is not uniformly distributed on the entire periphery or a weakness in material at the crack initiation point. The force exerted by the firing stroke however could exert an unbalanced and increased pressure around the periphery and the stress concentration occurring. The crack initiation was from such a grooved area. Microstructure shows the propagation of crack along graphite flakes in cast iron which are in fact tiny lamination in themselves and are a cause of stress concentration.

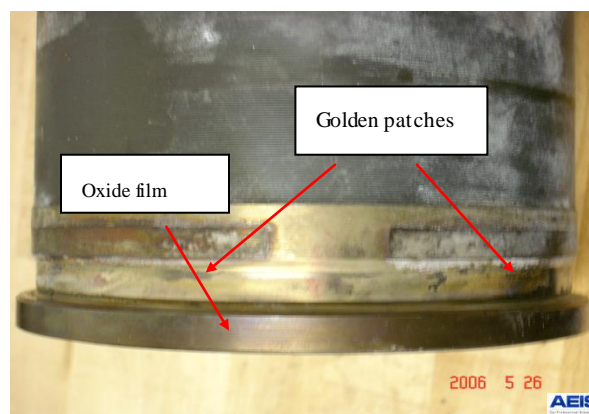
Cylinder liner Number 1016 had similar cavitation patches though deeper than cylinder liner number 277. The metal damage below the flange was observed in this cylinder liner too. The loss appeared to be similar in depth though on a lesser cumulative linear dimension. Cylinder liner Number 1076 in Fig 3 was found to be generally free of cavities, both on the general outside surface as well as under the flange. A small patch with a cumulative area of about one and a half square inch was found on the upper half of the liner. The cooling channel had some golden colored patches which appeared to be remains of an adhesive.

Figure 3: Close up of cooling channel area of cylinder liner 1076

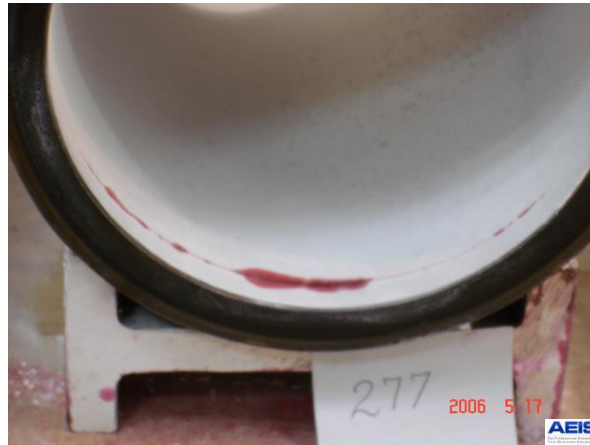
The inside surface of the liners was cleaned and examined by Liquid Penetrant Test technique. No crack was observed in cylinder Liners 1016 and 1076. The crack in the liner 277 covered approximately 50 percent circumference, showed in Fig 4.

Figure 4: Crack in Cylinder liner 277

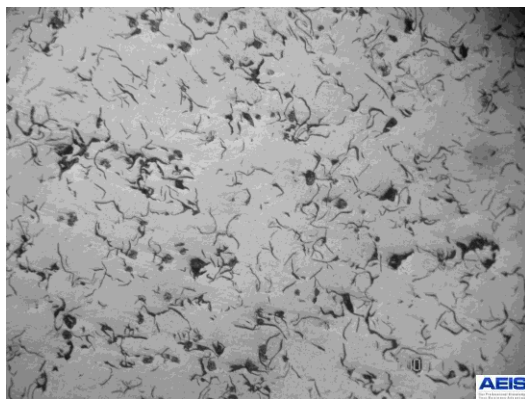
Figure 5: New Liner microstructure in the middle of the fire length in as polished condition. Magnification 100X

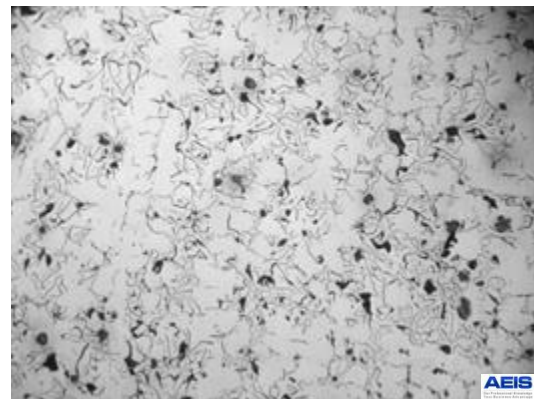
Figure 6: Liner 277 microstructure in the middle of the fire zone in as polished condition. 100X Magnification

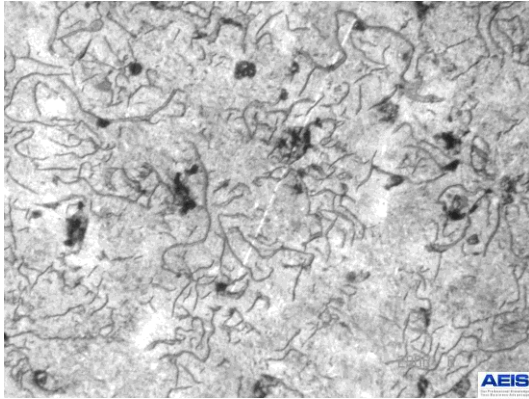
Figure 7: Microscopic structure of matrix the liner 1076. 250X Magnification

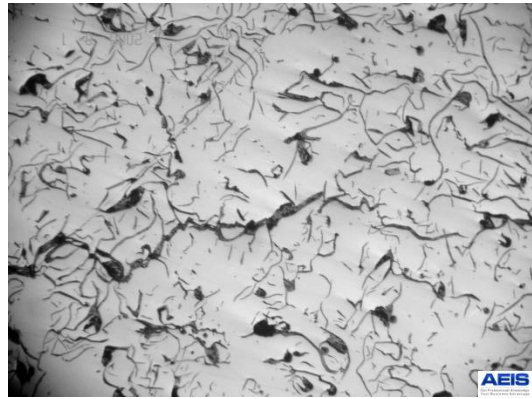
Figure 8: The crack propagation in liner 277 along the graphite flakes 200X Magnification

Microstructure showed that the graphite distribution in the new and the liner 1016 is similar where as liner 277 and 1076 show similarity. The matrix was found to be heat treated though under different parameters. The crack propagation in Liner 277 was along the graphite flakes and stress concentration points at the bottom of the pits.

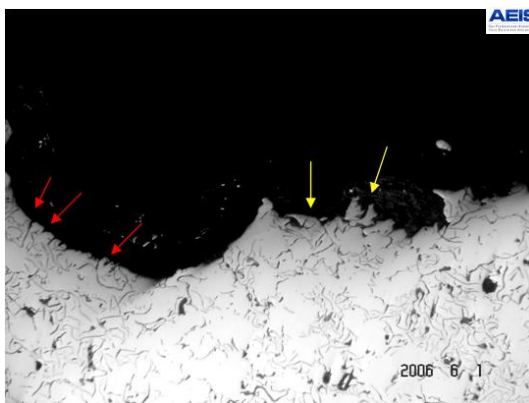
Figure 9: Stress points and attrition at the bottom of the cavitation pit 100xMagnification

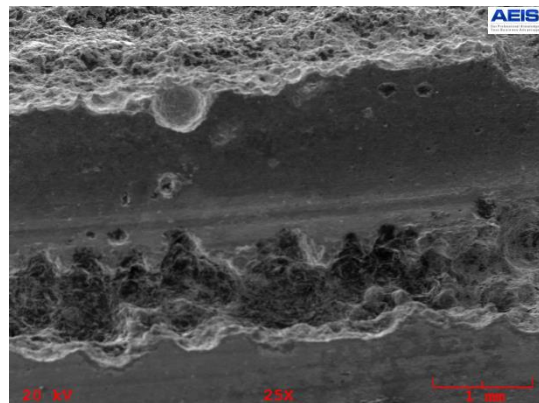
Figure 10: SEM photograph of fracture surface showing a pit profile
