Failure Analysis of a Excavator Heel due to Fatigue and HAZ

Key words: Excavator heel, Cracking , Fatigue , Welding, HAZ

Material : Cast Steel

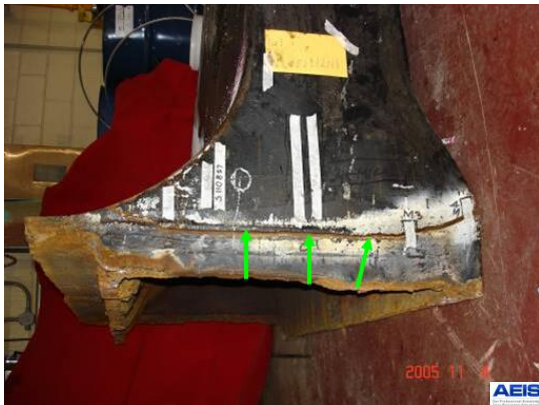
The main fracture of the beam was wrapped around an edge. The fracture ran generally along the upper toe of the weld for most of its length. There were two other cracks, both originating from the same location at the corner, figure 1. The fracture surface had lost fine features, basically, because of corrosion. The surface was wire brushed to remove rust and scale. The crack arrest marks pointed to two origins, in fig 3&4, one for the main fracture and the second for the other two smaller cracks. Both the origins were located at the upper toe of the inside weld.

Figure 1: The main crack

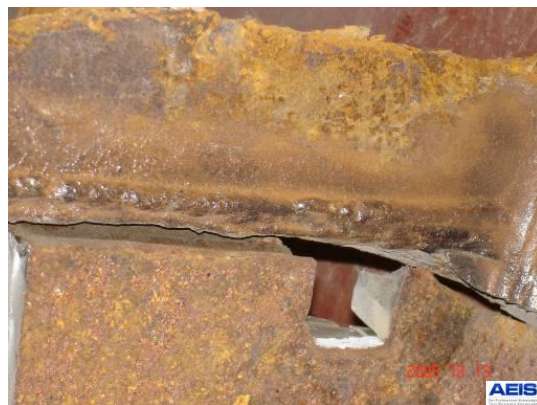
Figure 2: The main crack as viewed from inside the boom heel.

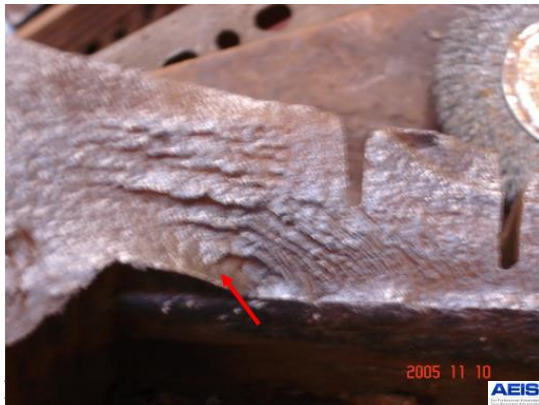
Figure 3: Origin of the main fracture as seen on the fracture surface

Though fine crack arrest marks had been obliterated by corrosion at the fracture surface, the remnants suggest that the failure originated at the toe of the weld to the deck. It is significant that all the three cracks initiated from the weld toes and progressed along the fusion line. The grain growth in the HAZ lead to an in homogeneity at the micro level. The metallurgical and mechanical notches created at the edge of the toe of the weld acted as stress concentration points that lead to the failure. It can not be said with certainty whether micro cracks had been introduced during welding itself or the residual stresses along with applied stresses initiated the cracks at a later stage. From the arrest marks it is evident that the crack growth was progressive in nature and was not a result of a sudden or single time overloading.

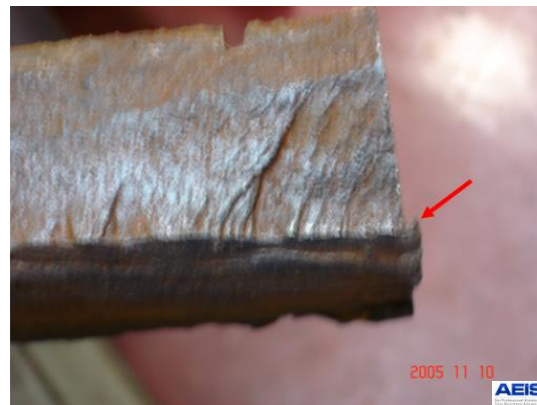
Figure 4: Origin of the other crack as seen on the fracture surface

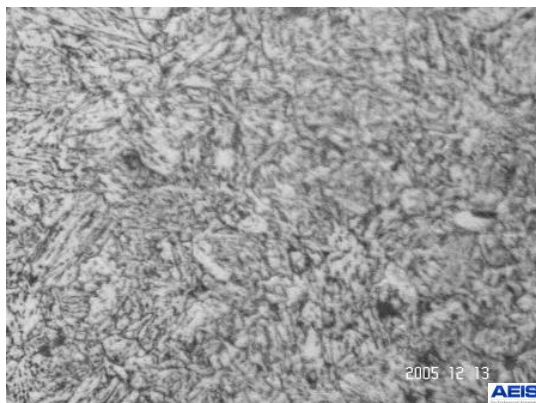
Micro specimens were prepared and evaluated under high power optical microscope. The examination revealed a fine grain structure consisting of ferrite and carbides in the parent casting, figure 5. Grain coarsening was observed in the HAZ near the origin of main fracture, figure 6.

Figure 5: Microstructure of the parent casting (600X)

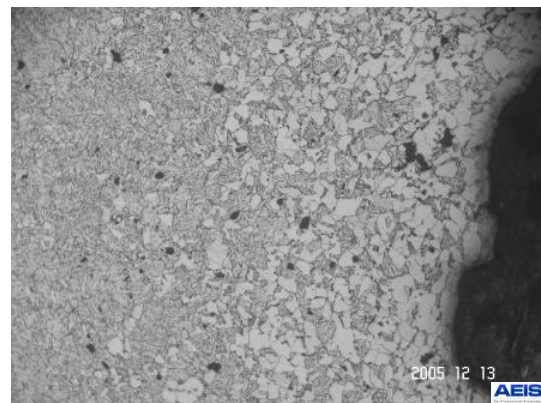
Figure 6: Grain growth in the HAZ near the main fracture origin (150X)
