## Failure Analysis of forty-eight Inch Cast Iron Water Main Pipe due to Overload

Key words: Cast Iron Pipe, Water Main, Mechanical stress

Material: Cast Iron

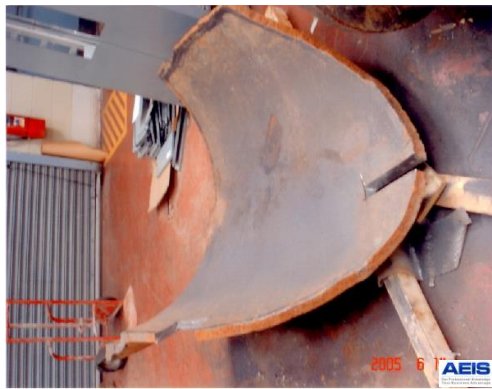
The pipe was observed to have failed by brittle fracture. The fracture originated at two locations in the bell and propagated in the longitudinal direction with the two paths converging to tongue tip profile, as seen in Figure 1.

Figure 1: Fractured off section of submitted pipe

The profile of the fracture suggests a mechanism where a wedge of the pipe at the bell is split off to relieve the bending stresses. Figure 1 taken at the failure site shows that the split had taken place on the side.

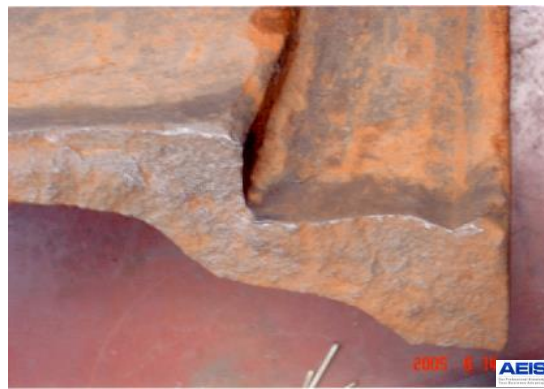
The outside and inside surface were coated with a tar like product. There was no evidence of any corrosive attack, such as pitting. The fracture edges showed no evidence of any localized thinning of the wall. The fracture surface at the bell was power brushed and examined, Figure 2. There were no remnants of any cement coating found on the inside surface.

Figure 2: Cleaned fractured surface at Bell End

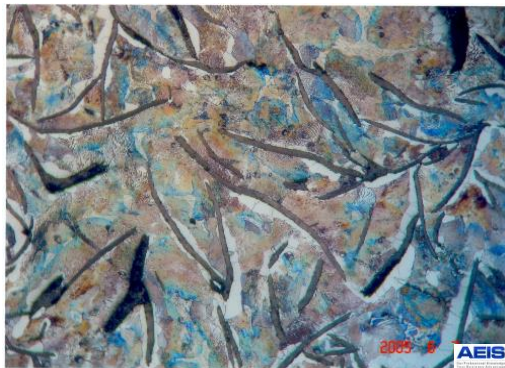
Figure 3: Microstructure of Middle of Wall  
 125x Magnification

At location 1 presence of graphitization on the inner surface to a maximum depth of 0.08 inch was observed, Figure 3. No graphitization was observed on the outer surface. The matrix consisted of Pearlitic plus ferritic structure, predominantly pearlitic in the middle, Figure 4 and gradually changing into ferritic towards the surfaces. The graphite flakes were found to be of type A/C and were finer near the surfaces.

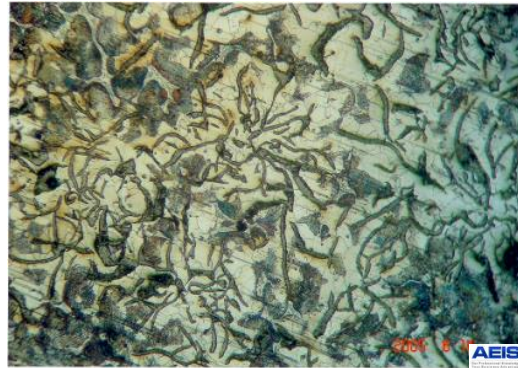
Figure 4: Microstructure at Outer Surface  
 125x Magnification
