Failure Analysis of Natural Gas Service Compression Fitting due to Sideway Overload

Atlas Evaluation & Inspection Services

Failure Analysis Case Study

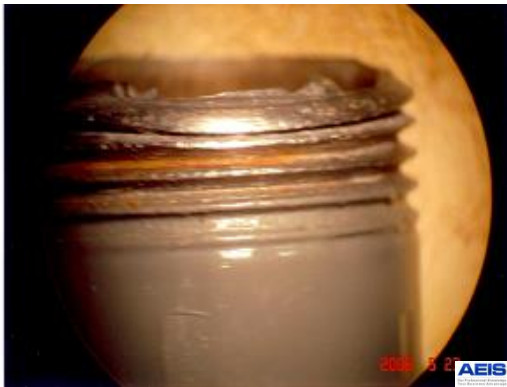
The assemblies had failed by fracturing of the threads at the end of the ¾ inch NPS coated steel pipe. Deformation of the threads can be seen in figure 1. Examination under a low power stereomicroscope show thinning in the area of the fracture. Stretch marks are visible on the inside diameter surfaces, figure 2.

Figure 1: Metal deformation at the fractured end of the pipe

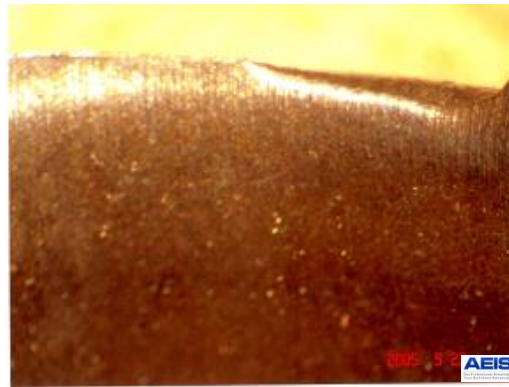
Figure 2: Stretch marks on the inner diameter

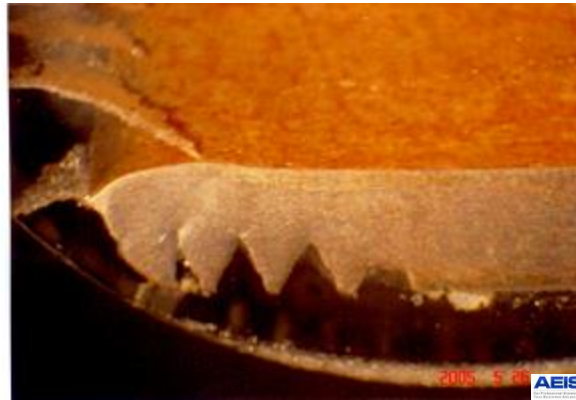
Figure 3: Evidence that fracture took place by a side load of the pipe

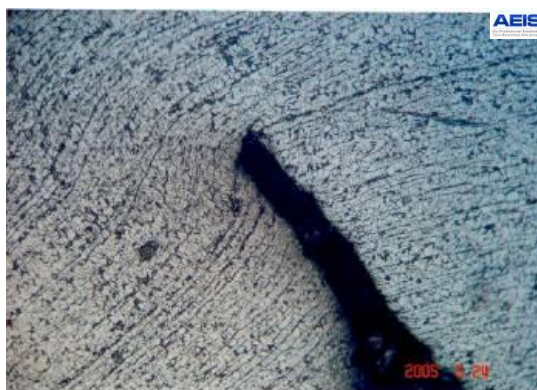
Figure 4: Side bending plastic flow, Concave Side 200x Magnification

The cross sections were then metallographically prepared and the examined under a metallographic microscope at magnifications up to 800x. Flow lines indicating plastic flow of metal due to side ways loading were observed on opposite wall locations in the fracture zone, figures 4 and 5. The threads have been machine cut but as opposed to being roll formed.

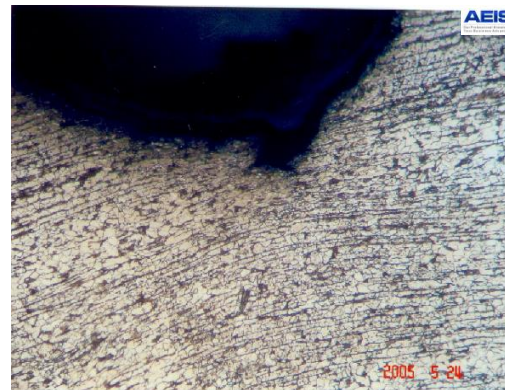
Figure 5: Slide Bending Plastic Flow, Convex Side 202x Magnification
