Failure Analysis of a Truck Axle due to Fatigue

Atlas Evaluation & Inspection Services

Failure Analysis Case Study

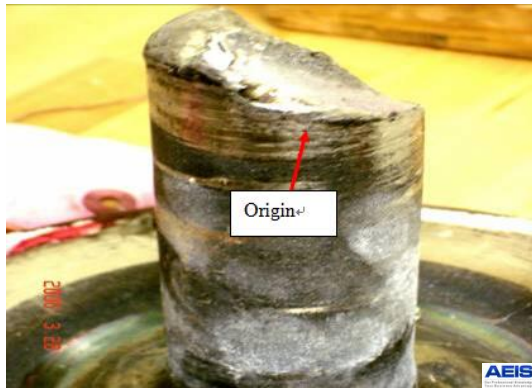
Scoring on the surface at the flange end fracture was observed, Figure 1. No scoring on the outside surface of the other fracture zone was observed. Both the fractures surfaces were roughly in a helical plane. The location of fractures may have a relationship to the anchoring points on the axis. Though much of the fracture features had been obliterated by rubbing of the mating surfaces, well defined markings could be seen in certain areas, in Figure 2.

Figure 1: Scoring on the surface the flange end

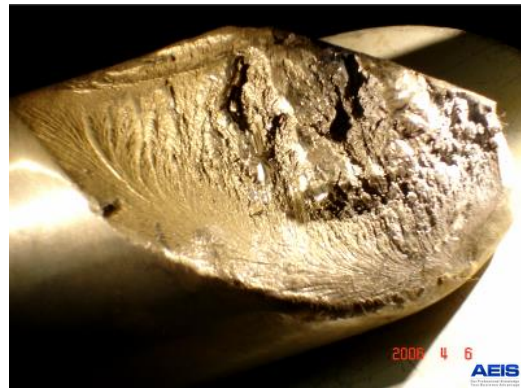
Figure 2: Markings on the fracture surface on spline end

Fracture markings indicate that the both the fractures took place under torsional loads beyond the capacity of the subject axle. Since the two fractures could not have taken place simultaneously and the flange end has score marks on the surface it is derived that that this fracture took place after the spline end fracture. The spline end fracture caused misalignment that resulted in jamming in the scored region. Chevron marks on the fracture surfaces indicate that the fractures originated from the surface or near the surface and propagated in the hardened case.

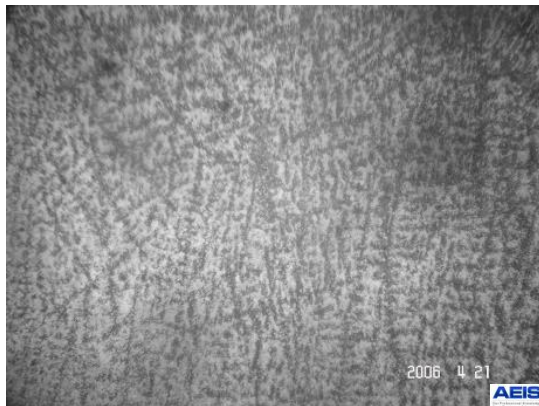
A specimen was prepared across the region of origin of spline end failure down to the core for microscopic examination. The examination did not show any non-metallic inclusion or discontinuity in the case and substrate. A sample taken from the middle of the failed axle was prepared for microscopic examination. The core had equi-axed grains while the zone between the hard case and the core showed Ferrite–Pearlite banding that had not been effectively homogenized in the blank.

Figure 3: Microscopic structure below the hardened Zone. Dendritic pattern 37.5X

SEM analysis ruled out the possibility of fatigue cracking that could have been induced by cyclic loading. Ferrite- pearlite banding was observed below the hardened zone. The banding is attributed to higher manganese content and is not considered to have any marked effect on the mechanical properties to have caused the failure.

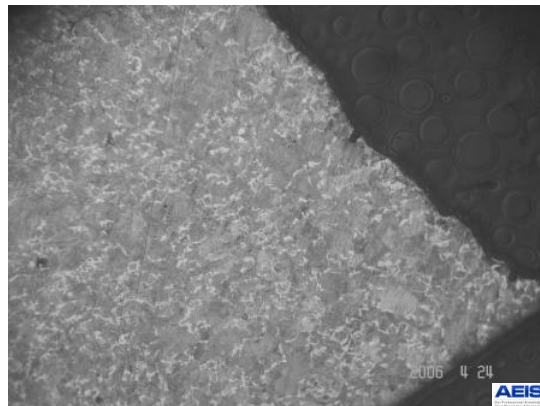
Figure 4: Microscopic structure at the core 200X

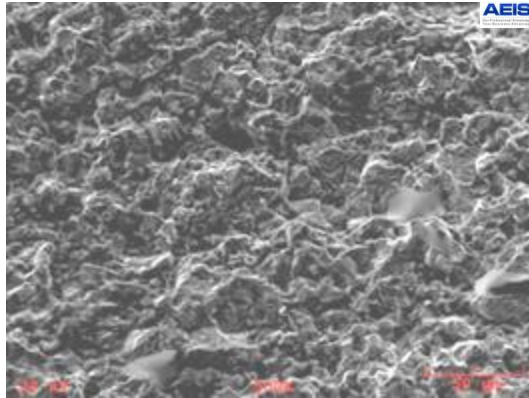
Figure 5: Fracture surface in the thumb nail zone SEM 500X

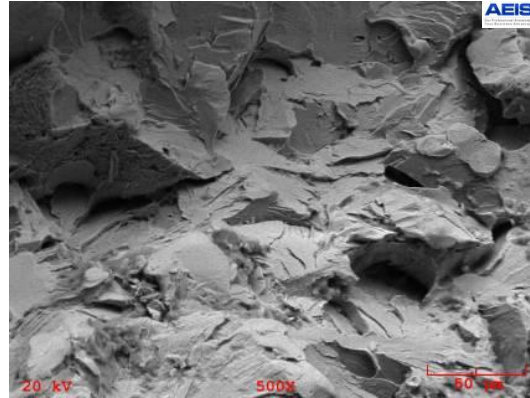
Figure 6: Fracture surface below the hardened edge SEM 500X
