Failure Analysis of a Brass Pipes due to Stress Corrosion

Keywords: Pipe, Cracking, Stress Corrosion

Material: Brass

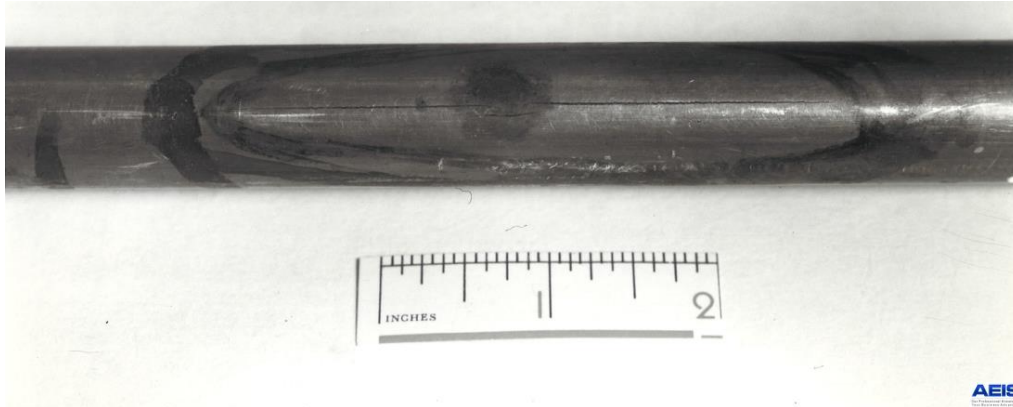
“NYCHA NO. 1” sample had a five inch long crack which was interrupted at its center, showed in fig 1. Both segments of the crack had winded. The other four lengths were free of any crack or other surface imperfections. The dimensions conform to the requirements for regular pipe sizes as shown

Fig 1 Crack on “NYCHA NO.1”

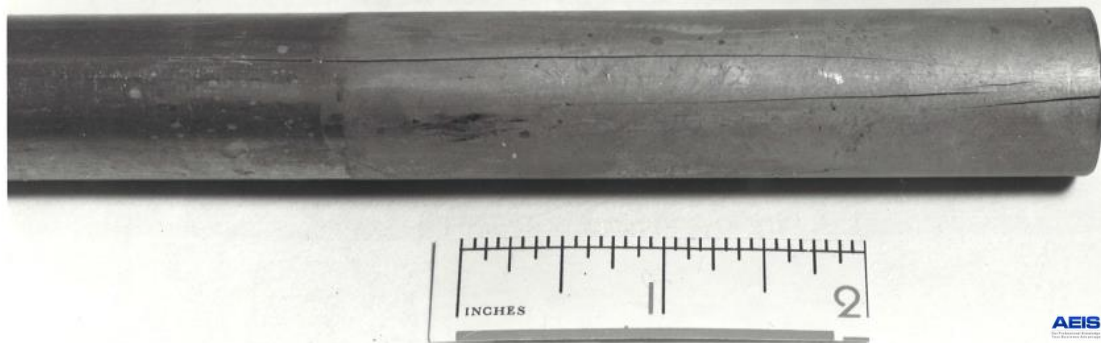
NYCHA sample Nos. 1 (1/2 inch N.P.S.), 3 (1/2 inch N.P.S.) and 4 (3/4 Inch N.P.S) developed cracks. Figure 2 shows the cracks on NYCHA sample No.3. NYCHA sample Nos.2(1-1/4 inch N.P.S.) and 5 (1 inch N.P.S.) did not develop any cracks and conform to the requirements of ASTM B 154-82

Fig 2 Cracking shows after mercurous nitrate test on NYCHA No.3

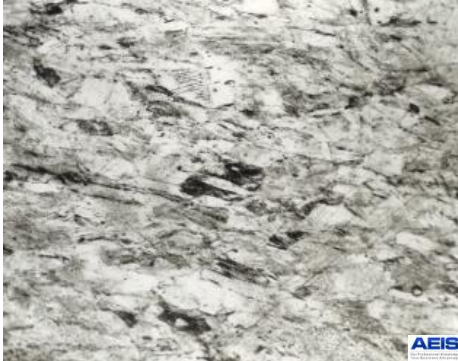
Transverse and longitudinal samples from both the No. 1 and No.3 pipes were mounted for metallographic examination. The crack widened further during cutting showing a high circumferential tensile residual stresses. In Fig 3, both pipes (Nos.1 and 3) were in as-drawn (old worked) condition which would be expected to contain residual stress. The fracture path in the No.1 and 3 pipe(after mercurous nitrate testing) was found to be intergranular and branched which is typical of stress corrosion cracking, showed in fig 4. Fig 5 shows the fracture to be intergranular and branched under SEM. The pipe is not in the annealed condition with complete recrystallization as required by ASTM B43-85.

Fig 3 Microstructure of No.1 pipe x200

The cause of the cracks found in NYCHA NO.1 pipe is due to the presence of high residual stresses in the pipe. Furthermore, the pipe is not in the annealed condition as required by ASTM B43-85. Annealing is a heat treatment that removes residual stresses that occur during manufacturing of the pipe.

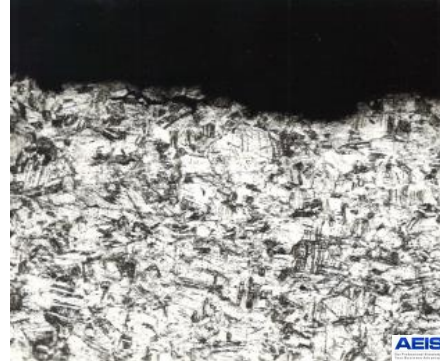
Fig 4 Intergranular cracking of No.1 pipe x200

There is no doubt that the mechanism of failure in the subject pipe is stress corrosion cracking. This is borne out by the fracture path which is intergranular and branched. The first requirement of SCC is stress which has been proven from cold drawn residual stress as showed in mercurous nitrates test and microscopic examination.

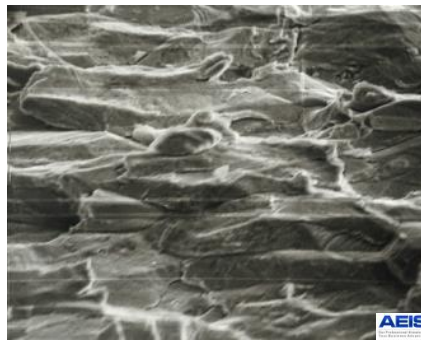
Fig 5 SEM of fracture surface on NYCHA No.1 X750
