## Failure Analysis of a Cable Puller due to torsional overload

Keywords: Cable Puller, Failure, Torsional stress

Material: AISI 1018 carbon steel

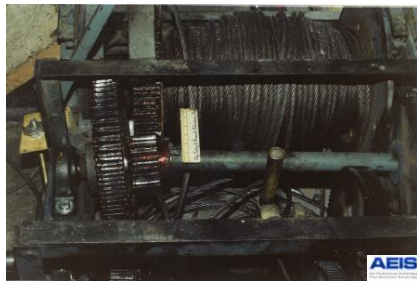
Fig 1 shows the gear arrangement to the drum containing the hoisting wire (1/2 inch dia.). Note that the drive shaft is bent which caused disengagement of the 4 inch diameter gear on the shaft from the drum gear. Fig 2 shows the shaft after removal from the unit. The shaft is obviously bent and fractured at the site of the inboard face of the small four inch gear. Note that there is severe torsional shear deformation in the bar in the area between the large drive gear (on the left in Fig. 1) and the 4 inch gear which drove the cable drum. This area experienced shear stress well in excess of the torsional yield strength of the shaft material.

Fig 1 Gear disengagement caused by the bent drive shaft

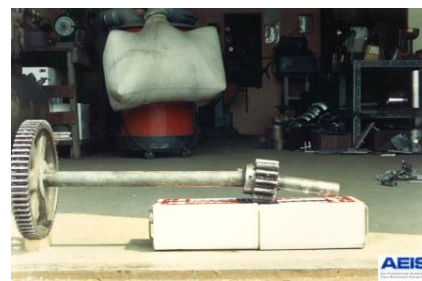
Fig 2 Bent and fractured drive shaft after removal from the unit

Note also that shear stresses in excess of the yield strength were also induced between the 4 Inch gear and the gear at the other end of the shaft (shown on the left in Figure 2). This is borne out by the bend at the end of the keyway in Figure 3. The fracture site in the shaft is also evident in this photograph. A series of punch marks were observed on the shaft surface. These were presumably placed there to assist in affixing the gear to the shaft. Fracture of the shaft took place through one of these punch marks. (Just below keyway, Figure 4). Fracture had begun through some of these marks which were further evidence of the high torsional stresses experienced by the shaft.

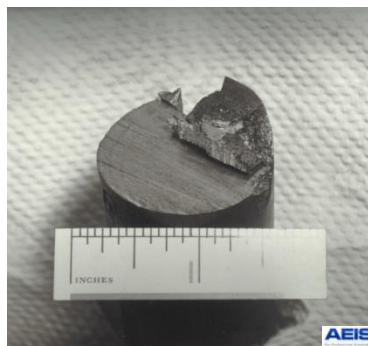
Fig 3 Fracture site at the end of keyway

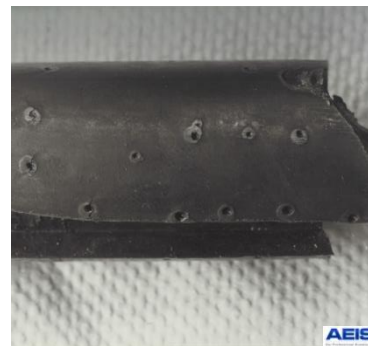
Fig 4 Fracture begun through one of the punch marks

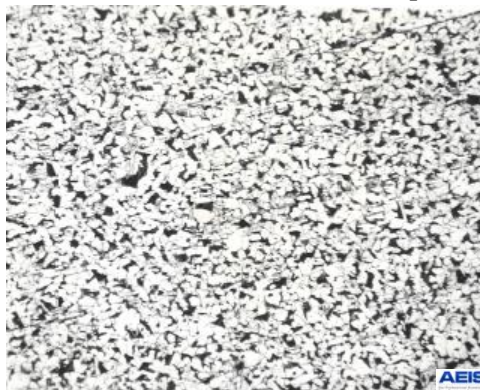
Fig 5 showed microstructure of the slice from hardness test. The microstructure observed was that of a hot rolled mild steel bar which consisted of equiaxed ferrite plus pearlite.

Fig 5 Microstructure of the fractured drive shaft X100
