Failure Analysis of a Cable Support Strap due to Stress Corrosion Cracking

Atlas Evaluation & Inspection Services

Failure Analysis Case Study

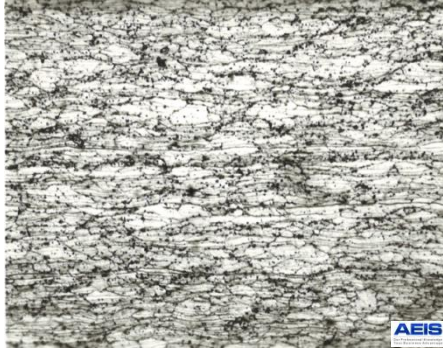
Samples were cut from fracture surface and unused straps for metallographic examination. The microstructures of the failed and new samples were the same. It consisted of elongated (cold rolled) grains of zinc rich primary solid solution interspersed with small particles of a second phase, presumably a zinc—copper intermetallic compound. Figure 1 is a photomicrograph (500X) showing this microstructure. Figure 2 shows the fracture surface in cross-section. Branching of the main fracture is evident.

Fig 1 Microstructure of failed sample X500

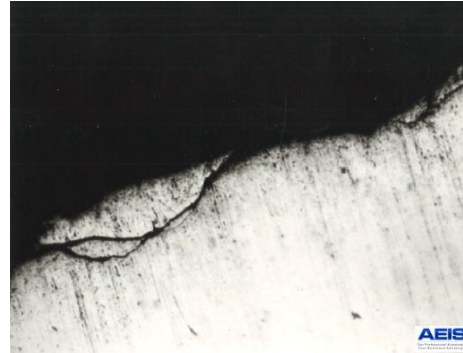
Fig 2 Cross-section of fractured surface X500

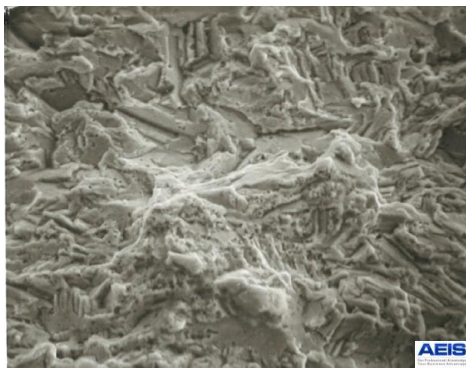
An additional sample was cut from one of the fracture surface areas and used for scanning electron microscopic (SEM) study. The examination showed the fracture to be mainly transgranular. However, several areas of crack branching were observed. Figures 3 & 4 are SEM photos showing two areas on the fracture surface examined. Note the presence of cracks going into the sample body (branching).

Fig 3 SEM of fractured surface X650

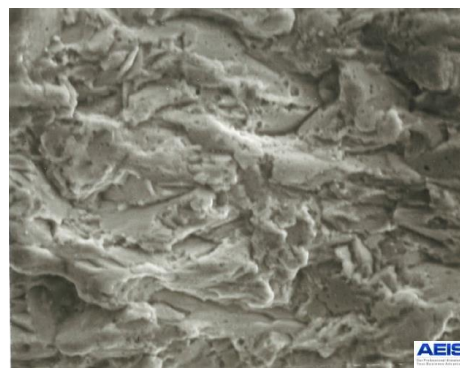
Fig 4 SEM of fractured surface X1000
