Failure Analysis of a Hot Water Heating System Pipe due to Pitting

Failure Analysis Case Study

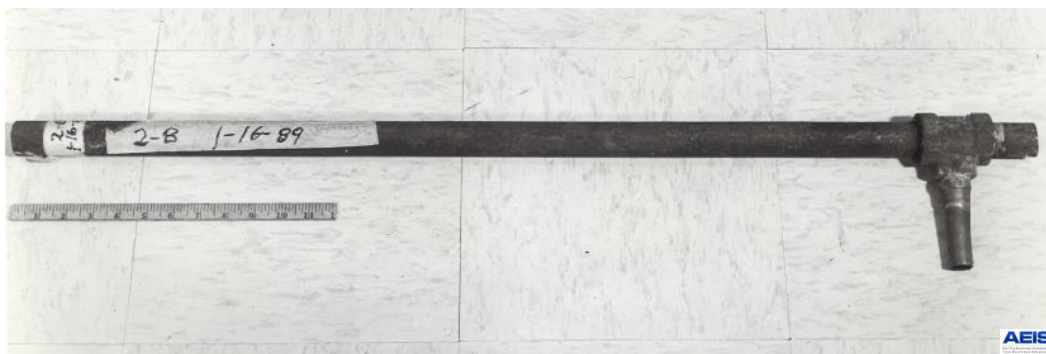
Figure 1 is a photograph showing the pipe section as it appeared when it was received. Note the pinhole in the pipe at the three inch marker on the ruler. This pin hole is show again in closer view in Figure 2. Some corrosion is present on the outside surface of the pipe in the area surrounding the pin hole; this corrosion, however, is superficial and was not the cause of perforation. The perforated end of pipe section was longitudinally cut for a length of approximately eight inches in order to expose the inside surface. Figure 3 shows the inside surface thus exposed. The pin hole can be seen can be seen at the three inch marker on the ruler. It is obvious that the perforation was the result of severe pitting corrosion. This corrosion is present over the entire inside surface of the pipe and is covered with thick generalized tuberculation corrosion product. Many other pits are present in the tube wall, some of which are near to the point of complete perforation of the wall.

Fig 1 Pipe with pinhole at the end as received condition

with the appropriate corrosion inhibitors. Such pipe can be used in cold water system which conveys temporarily hard water, in as much as the calcium carbonate acts as such inhibitor. However, in hot water systems the calcium carbonate precipitated out at the heater thus leaving the water soft and highly corrosive to steel or the galvanized layer. In such systems copper or brass pipe is normally used. There is no doubt further leaks will develop in the system. The presence of tubercles will serve to assist in the deepening the existing underlying pits. This is the autocatalytic nature of the pitting process. Furthermore, the pitting has progressed to such an extent that cleaning the system and then attempting to stem further corrosion by inhibition is not likely to be effective. It is therefore recommended that the system be replaced with copper pipe.

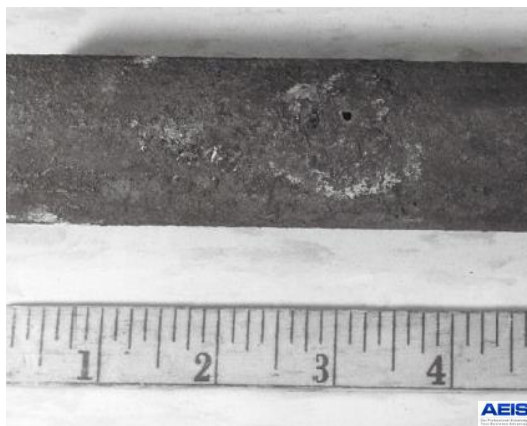
Fig 2 Close look of the pinhole

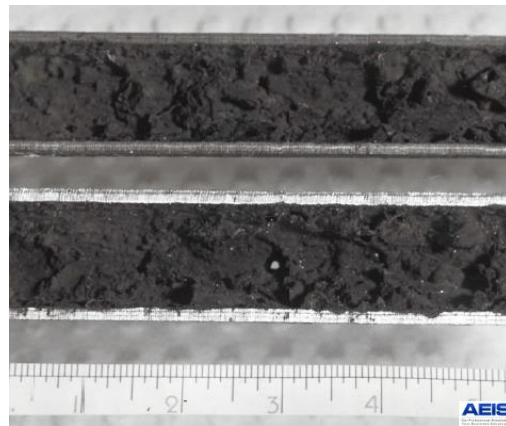
Fig 3 Inside surface of the pipe

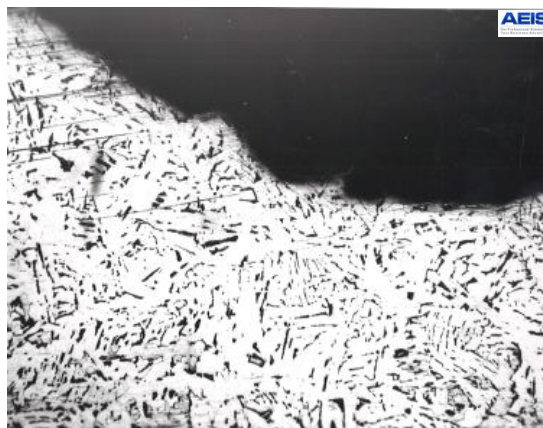
A sample containing a pit was mounted and prepared for metallographic examination which revealed that the pitting corrosion was transgranular and was in no way related to microstructure. Figure 4 is a photomicrograph (100X) showing a portion of a deep pit in cross-section. The general microstructure is typical for steel pipe in that it consists of a matrix of ferrite with zones of pearlite. Note that the corrosion is generalized.

Fig4 Microstructure of pipe X100
