## Failure Analysis of a Tie Rod due to Impact

Keywords: Tie Rod, Fracture, Bending, Impact

Material: Steel

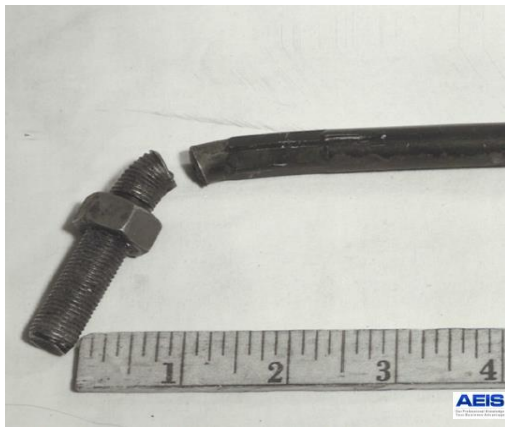
Figure 1 is a photograph of the subject tie rod end as it appeared when submitted. Failure had taken place at the last thread from the threaded end of the tie rod. It is apparent that failure was caused by severe bending forces which first caused almost right angle bend in the tie then fracture. The compression of threads on the concave side and the stretching of the thread on the convex side are evident. The root of the thread adjacent to the fracture was also observed to have been cracked on the convex side. Figure 2 is a close-up photograph of the mating fracture surfaces. The fracture surfaces are decidedly due to bending with tensile failure starting at the convex side of the bend and progressing across the tie rod cross-section to the concave side which experienced first compression and then tension. Moreover, the fracture texture is indicative of bending overload failure. No evidence of any defect was found in the fracture surfaces.

Fig 1 Fracture tie rod as received condition

The rod was found to be sound and normal with no evidence of any material or manufacturing defect observed. Failure of the tie rod end was caused by severe bending loads which resulted in both bending deformation and ultimate fracture. This type of failure is typical of that caused by impact.

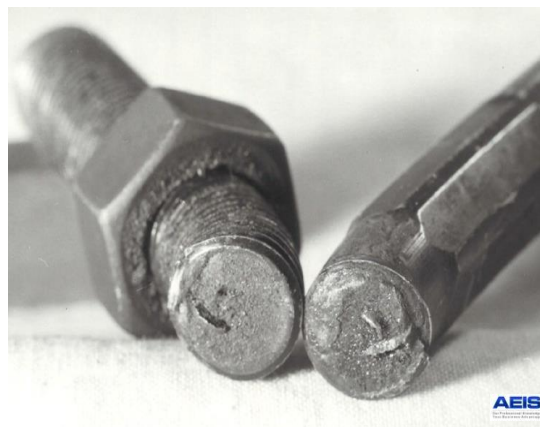
Fig 2 Close look of fracture surface

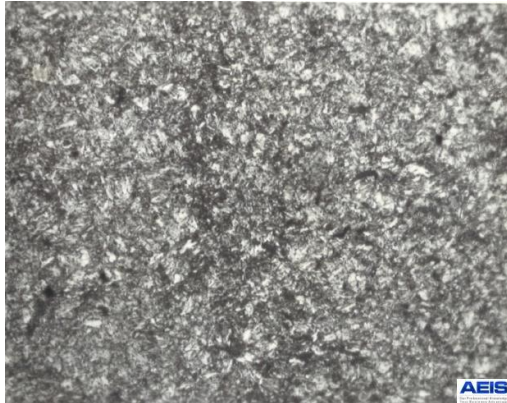
revealed the rod to be a steel in the heat treated (quenched and a tempered) condition with a tempered martensitic microstructure. Figure 3 a photo— micrograph (500X) showing this structure which is normal for a hardened steel. A small band of decarburization was observed at the tie rod surface but this is not considered a factor in the failure of the tie rod.

Fig 3 Microstructure of fractured tie rod X500

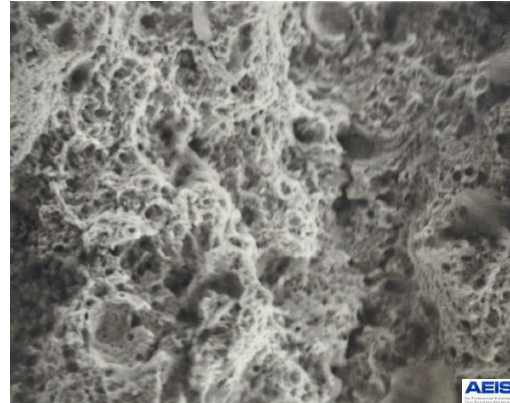
Scanning electron microscopic examination of fracture surface on the sample cut from the long section of the rod uncovered no evidence of any defect in the material. Similarly, no evidence of progressive (fatigue) failure was found. What was observed was a failure mode typical of overload of a sound, ductile material. That is, the fracture texture was what is commonly called a “dimple” structure. This is shown in 4 which is a SEM fractograph (1000X) of an area on the fracture surface. The SEM finding confirm what was observed by visual examination and stereomicroscopic examination.

Fig 4 SEM image of fracture surface X1000
