## Failure Analysis of a Compressor Valve Disk due to Fatigue

**Keywords:** Compressor, Valve Disc, Fatigue

**Material:** Alloy Steel

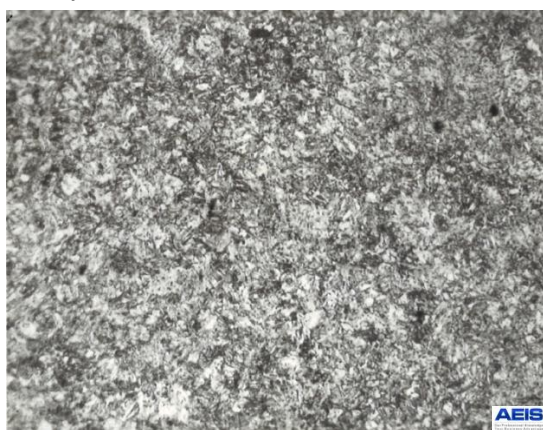
A metallurgical sample taken from an “A” disc was suitably prepared and examined. The structure found was tempered martensite which indicated that the disc was quenched and tempered. Presumably the tempering temperature used was too high resulting in the lower hardness. Figure 1 is a photomicrograph (500X) showing the observed microstructure. A sample containing fracture surface was cut from both “A” and “M” discs. The samples were

Fig 1 Microstructure of “ARESCO” disc shows a tempered Martensite structure X500

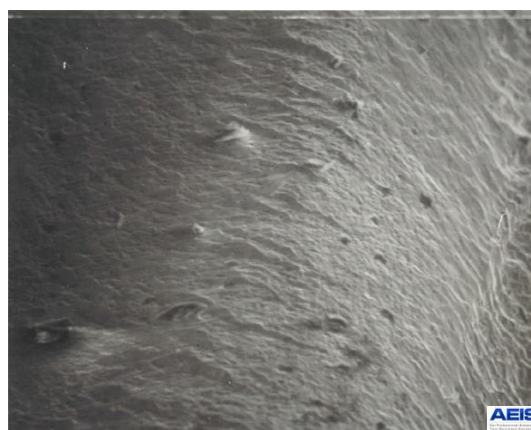
chosen from areas of fracture that were somewhat less burnished in an attempt to find a fracture surface which was undamaged and thus determine failure mode using scanning electron microscopy (SEM). Figure 2 is a SEM micrograph taken at 100X showing a relatively undamaged fracture area on an “M” sample. The texture, suggestive of fatigue failure in that there are typical “beach marks” on the surface. Figure 3 is an SEM fractograph at higher magnification (800X) taken on an “M” sample. Here we see definite fatigue striations in paths of unburnished surface. In this fractograph the flat, featureless (burnished) surface and the horizontal striped areas are zones of fatigue striations. It should also be pointed out here that no evidence of intergranular and/or branched cracking was found on any of the fracture surfaces examined.

Fig 2 SEM of “MIDWEST” disc shows typical fatigue structure X100

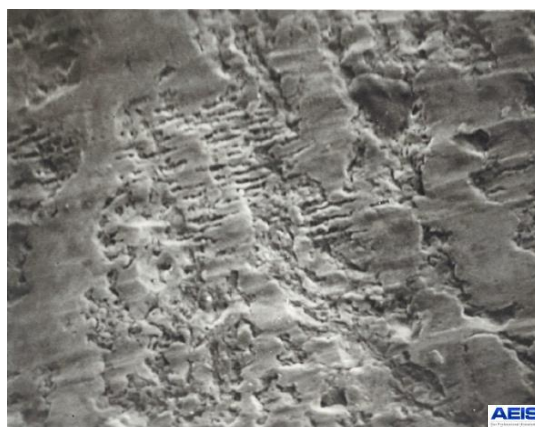
Fig 3 SEM of “MIDWEST” disc shows typical fatigue structure X600
