Failure Analysis of a Truck Leaf Spring due to Fatigue

Keywords: Truck, Leaf Spring, Fatigue, Cracking

Material: Alloy Steel

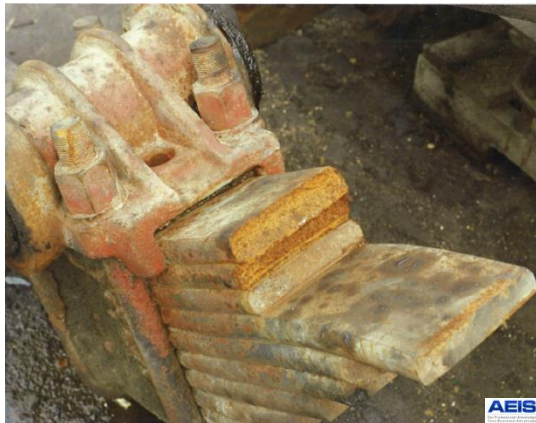
Figure 1 is a photograph showing the leaf spring assembly as it appeared when submitted. Note that the three longest leaves failed on one side (upper left). It should be pointed out here that the spring set is placed upside down in this photograph. In figures, the fracture surfaces on the three fractured leaves, arbitrarily designated 1, 2, and 3, top to bottom in the photographs. The fracture surfaces on leaves one and two are more severely corroded than leaf three indicating quite strongly that the fractures in leaves one and two anteceded the fracture in leaf three. Also significant is that all three fractures are brittle in nature showing no plastic deformation adjacent to the fractures.

Fig 1 Fractured Leaf Spring as received condition

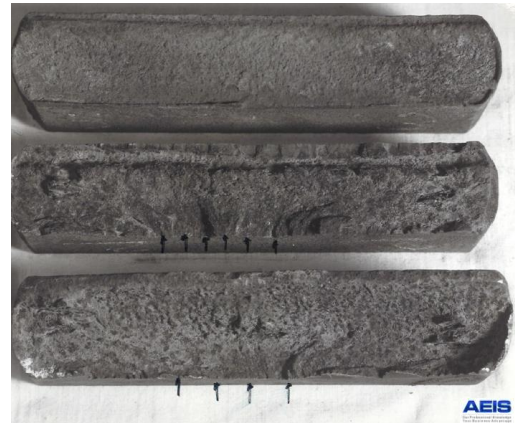
The fractures were cut from each of the three leaves in order to conduct further visual examination. Although these surfaces are rusted (particularly 1 and 2), the origin of final fracture is evident. In order to more clearly define the fracture texture, the sections were cleaned with a solution of citric acid and ammonia. This treatment removes rust but does not attack the underlying metal. The final fracture origins illustrated in Figure 2 are much more clearly defined as are other pertinent structural features. The fracture origins are flat and typical of progressive (fatigue) failure. Moreover, there is a zone of fatigue fracture on the sides opposite the side from which final fracture occurred. This zone is indicated by arrows in Figure 2. The fatigue crack on the opposite side would necessarily have come about due to upward bouncing of the truck body since under normal conditions these sides are in compression. Compressive stress cannot cause fatigue.

Fig 2 Fatigue feature showed on fracture surface on leaf 1&2

The foregoing observations indicate strongly that the leaves all underwent fatigue cracking during a particular period of service and spring leaves one and two had finally fractured through, due to the presence of the fatigue cracks, at some time prior to the day that the accident occurred. Owing to the weakened condition of the spring set due to failure of leaf one and two, leaf three failed during service thus causing complete instability in the wheel set and ultimate overturning of the vehicle.

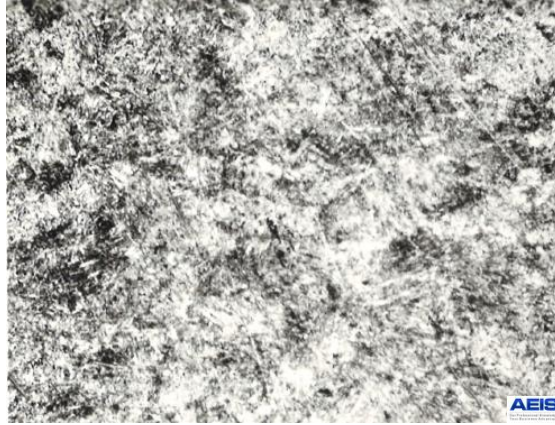
Metallographic samples were taken from each of the fractured springs and suitably prepared for observation of microstructure which was found to be tempered martensite in all three leaf springs. Figure 3 is a photomicrograph (500X) showing this structure in leaf three and is typical of what was found in the other two leaves.

Fig 3 Microstructure of leaf 3 shows tempered martensite X500
