Failure Analysis of a Screw due to Fatigue

Keywords: Cap Screw, Fracture, Fatigue

Material: Steel

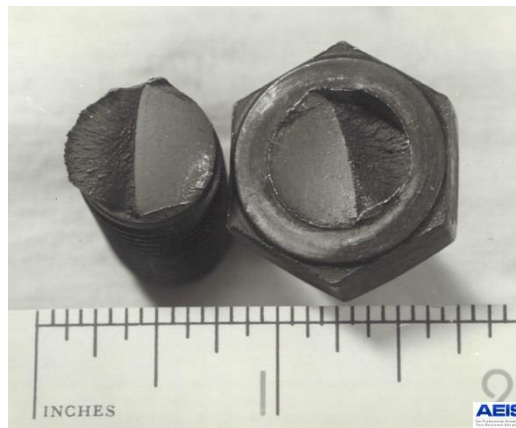
Figure 1 is a photograph showing the two mating fracture surfaces. Failure had taken place by complete separation of the head from the shank. A major portion of the fracture was located at the fillet between the head and the shank. There are two distinct zones on the fracture. The first, light area, is a brittle conchoidal fracture texture and the other a fibrous, silky fracture texture typical of overload of a strong, tough material. The light conchoidal zone showed evidence of fracture surface rubbing. There were also several areas at its periphery which appeared to be fracture origins. Fracture therefore was initiated at several sites and propagated across approximately one half of the shanks cross-section when final fracture (dark area) occurred. The light area is typical of progressive (fatigue) fracture.

Fig 1 Fractured cap screw as received condition showing a fatigue fracture structure

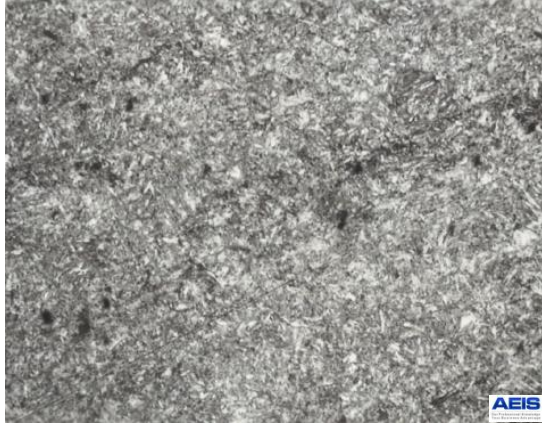
Hardness tests conducted on the screw shank revealed a hardness of Rockwell C39. This is in keeping with the observed microstructure. This level of hardness reflects a strength well above that required for a grade 8 bolt.

Two small samples were cut from the shank of the screw and mounted so show a transverse and longitudinal cross-section. After suitable preparation, the samples were metallographically examined. The microstructure of the screw material was found to be tempered martensite which indicates that the screw was in the heat treated (quenched and tempered) condition. Figure 2 is a photomicrograph (500X) showing the microstructure. The end of the shank containing the fracture was cut away and used for scanning electron microscopic (SEM) study. This examination revealed that the light zone was indeed a fatigue area. Figure 3 is an SEM fractograph (800X) showing the fracture surface at one of the origins on the light area. Note the striation typical of fatigue. Contrast this to the fracture

Fig 2 Microstructure of fracture screw showing a tempered martensite structure X500

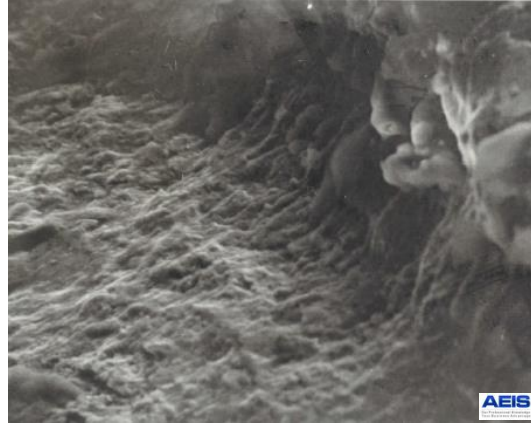
Fig 3 SEM at one of the fracture origin on the light area X800

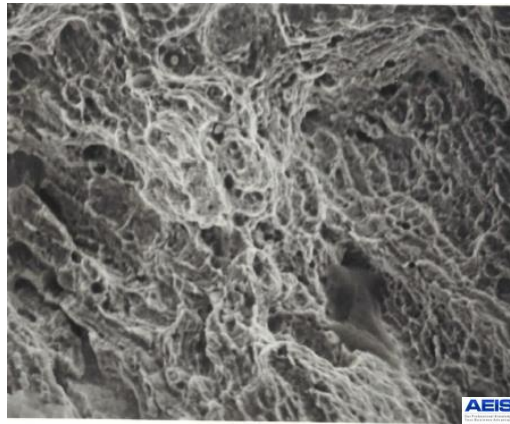
found in the dark area of the fracture shown in the SEM Figure 4 (800X). Here we have a dimple texture typical of tensile overload of a tough ductile material.

Fig 4 SEM of fracture surface at dark area
